Case Study: Miami Dade Water and Sewer Department Water Main Break Surface Reinstatement

Initial Installation

Solution: EZ Street

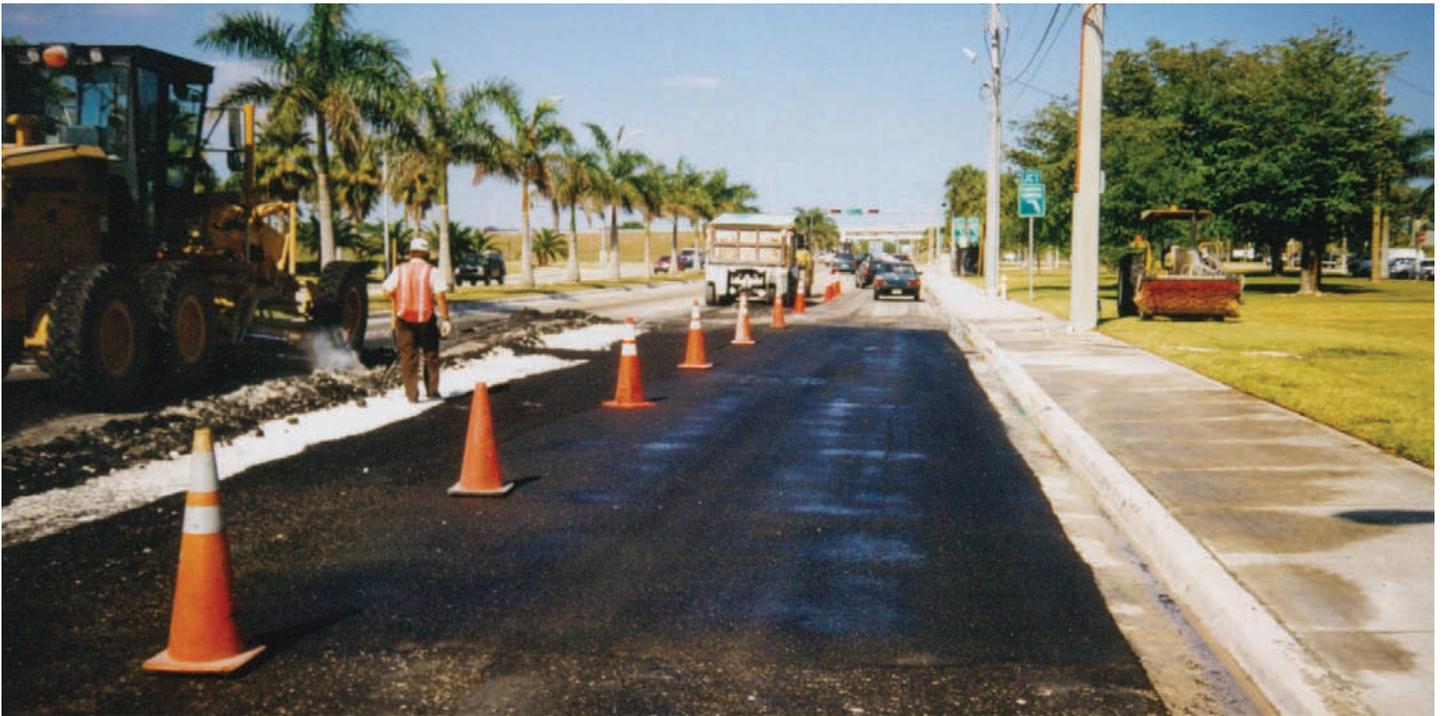
In the early morning hours of April 24, 1998, Miami Dade Water and Sewer Department (MDWS), the third largest water and sewer district in the United States, responded to a major water main break on SW 211th Street that spanned all three east bound lanes. MDWS crews proceeded to fix the break, replace the fill with insitu material, and capped the area with a temporary cold patch. By early morning rush hour, the material had given way to traffic and had experienced severe rutting, rendering the street impassable. "It was like a roller coaster through there," commented the MDWS region inspector.

MDWS typically would have removed the conventional cold patch and paved with hot mix. However, there were no hot mix paving crews available that day. MDWS engineers, in need of a permanent repair on the roadway, but lacking the crew and equipment for conventional paving, sought out the use of a relatively new product called EZ Street Asphalt.

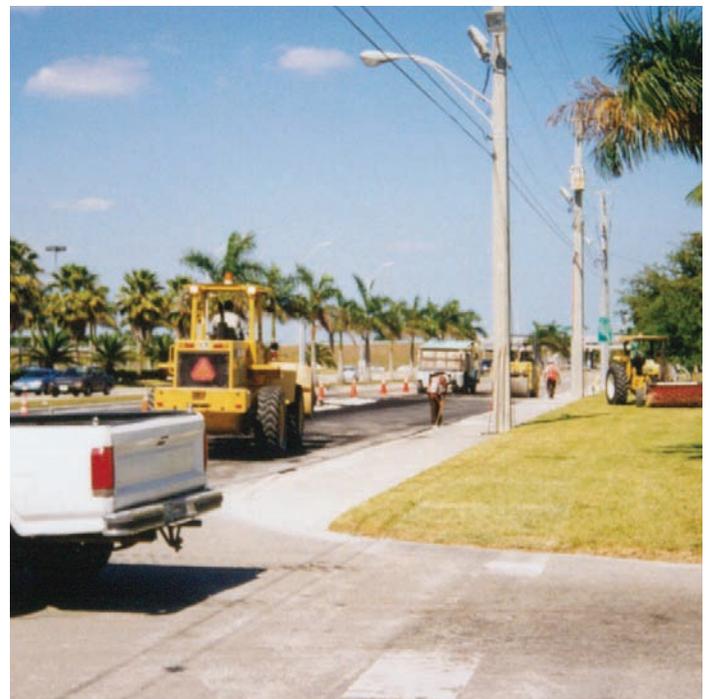
After a decision was made to use EZ Street, the crews executed a lay down plan that involved installing EZ Street in two, one and a half inch to 2 inch lifts by blading the mix with a motor grader and compacting each layer with a large steel wheel roller. One and a half lanes were closed off for working and allowed traffic to continue on this busy thoroughfare. Upon completion of the 1.5 lanes, the other 1.5 lanes were finished.

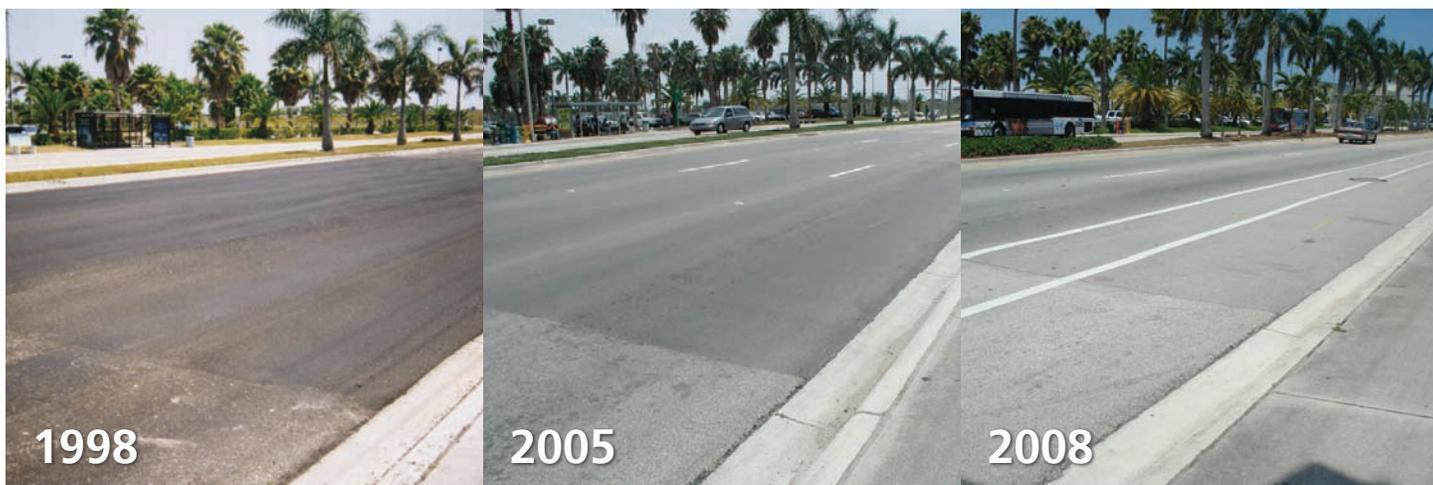
The patch overlay was subsequently monitored for the weeks, months, and years following its original installation on April 24, 1998. As of October, 2012, over 14 years since its original installation, the entire section has performed as well as the surrounding hot asphalt sections. The EZ Street section has effectively performed as a permanent hot mix alternative solution.

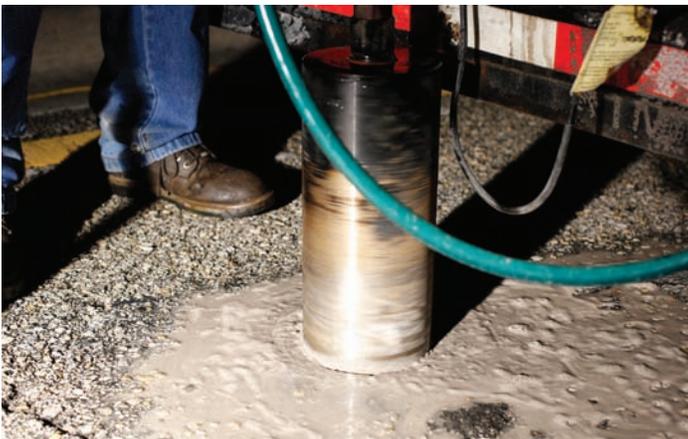
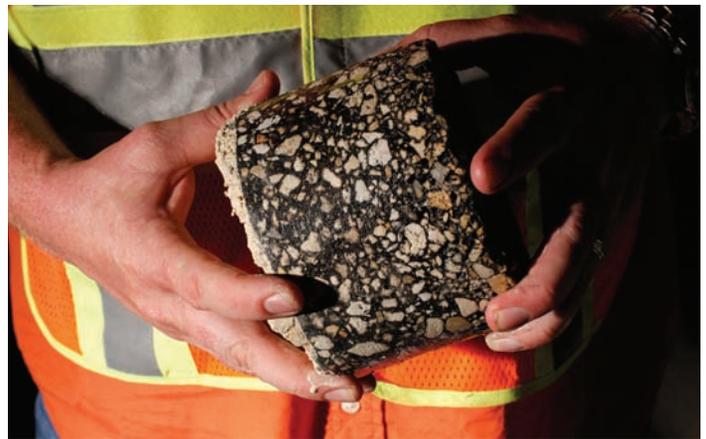
Cores were obtained in all three lanes, separated into top lifts and bottom lifts, heated, compacted and evaluated for stability and flow. Upon visible inspection, the cores were remarkably intact given the 14 years after installation.

Section	Stability (75 blow)	Flow
Top Lift	9260	12.5
Bottom Lift	6587	10.5

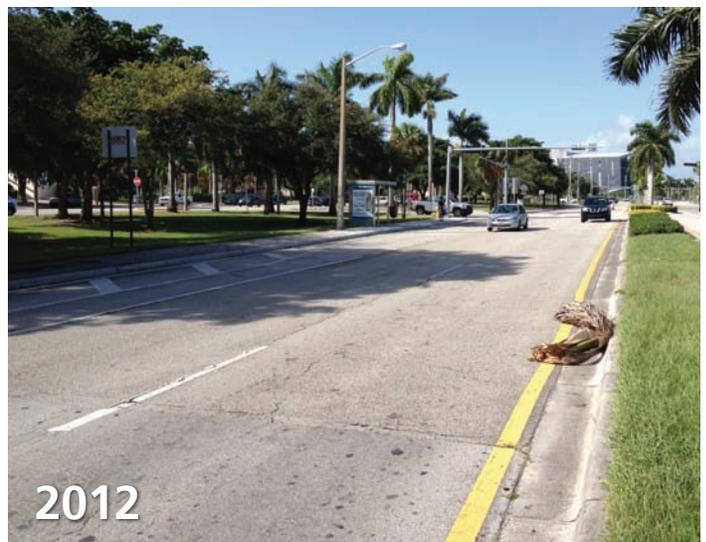
Below is a picture of the pavement section as of October 24, 2012. The section intersects what would have been a standard hot mix surface course design.
